RE: Waikiki War Memorial Natatorium

**EXISTING BUILDING STRUCTURAL
CONDITION REPORT**

WAR MEMORIAL NATATORIUM

EXISTING BUILDING STRUCTURAL CONDITION REPORT
WAR MEMORIAL NATATORIUM

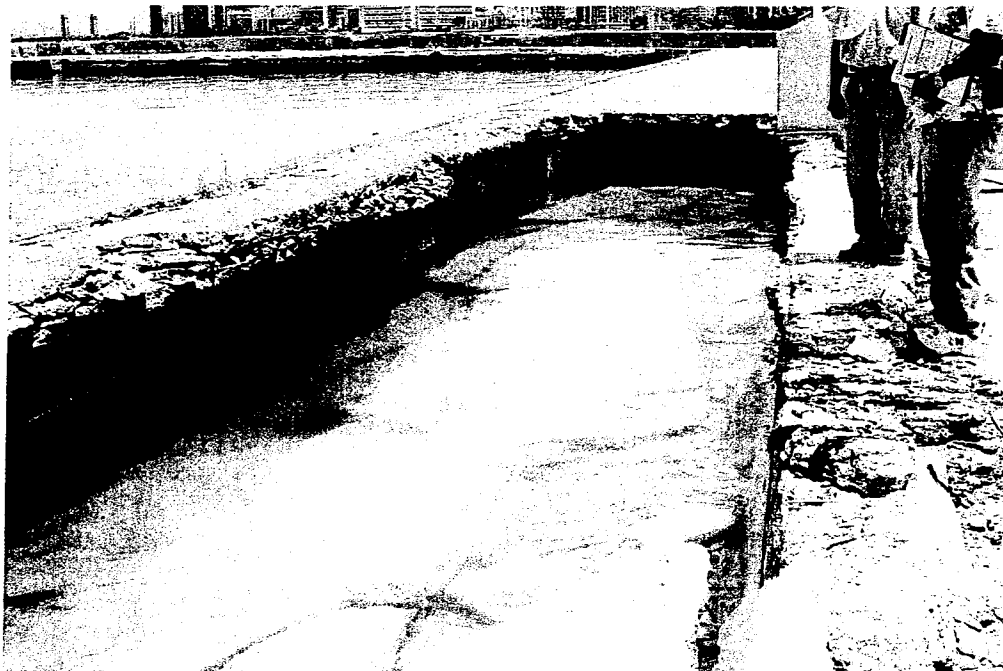
Three separate sections of the concrete pool deck were observed to have collapsed into the swim basin. The sections of the concrete deck at the ewa (Photo 4) and Diamond Head (Photo 3) ends of the swim basin reportedly collapsed many years ago and the resulting openings were covered with plywood. The section of the pool deck on the mauka side of the swim basin reportedly started collapsing in early 2004 with sections of both the original 6" slab and 6" topping slab that was added in 1949 falling away from the supporting foundation wall and the concrete beams. In the areas immediately to either side of the collapsed section along the bleachers, sections of the original concrete slab were observed to have fallen away with only the 6" topping slab remaining above (Photos 1 and 2).

Photo 1 - Pool Deck Collapse – Mauka Side (Along Bleachers)

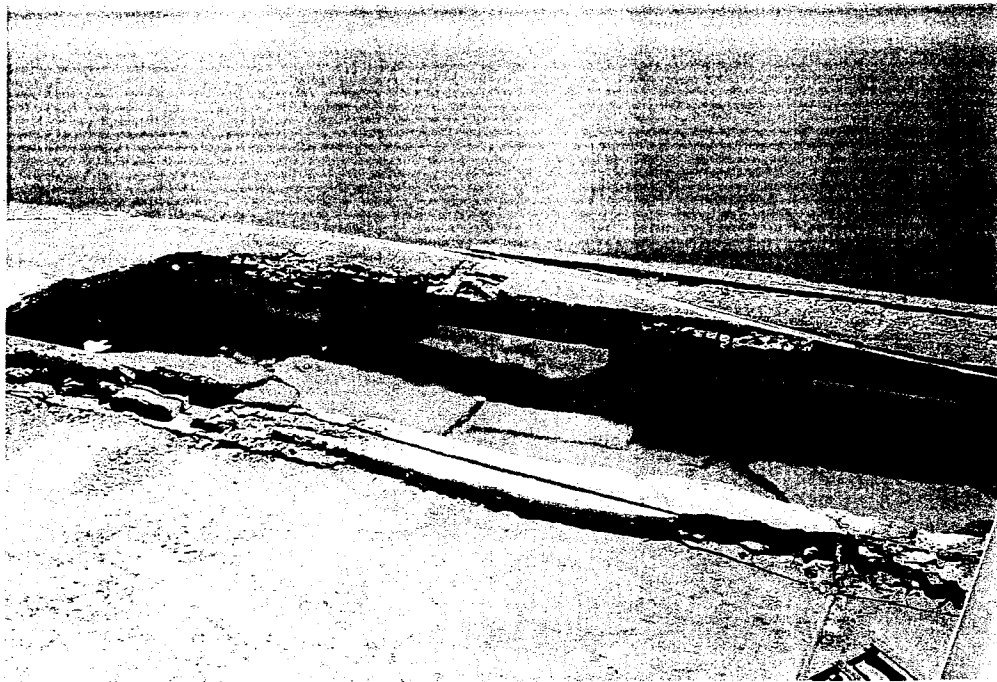
Photo 2 - Pool Deck Collapse – Mauka Side (Along Bleachers)

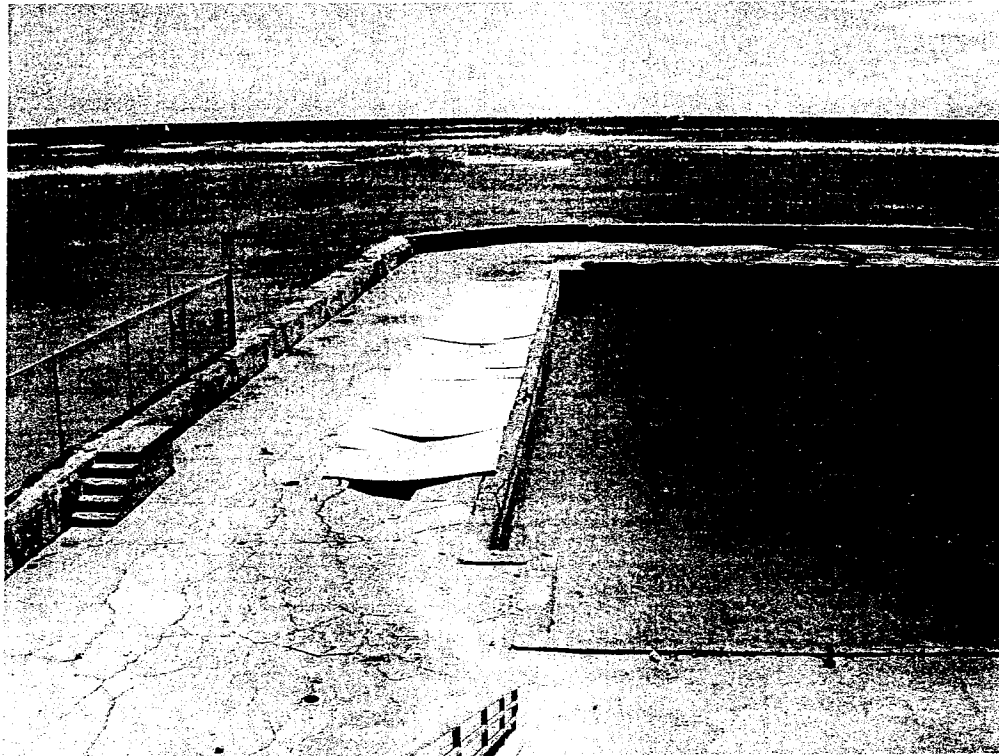
Photo 3 - Pool Deck Collapse – Diamond Head End

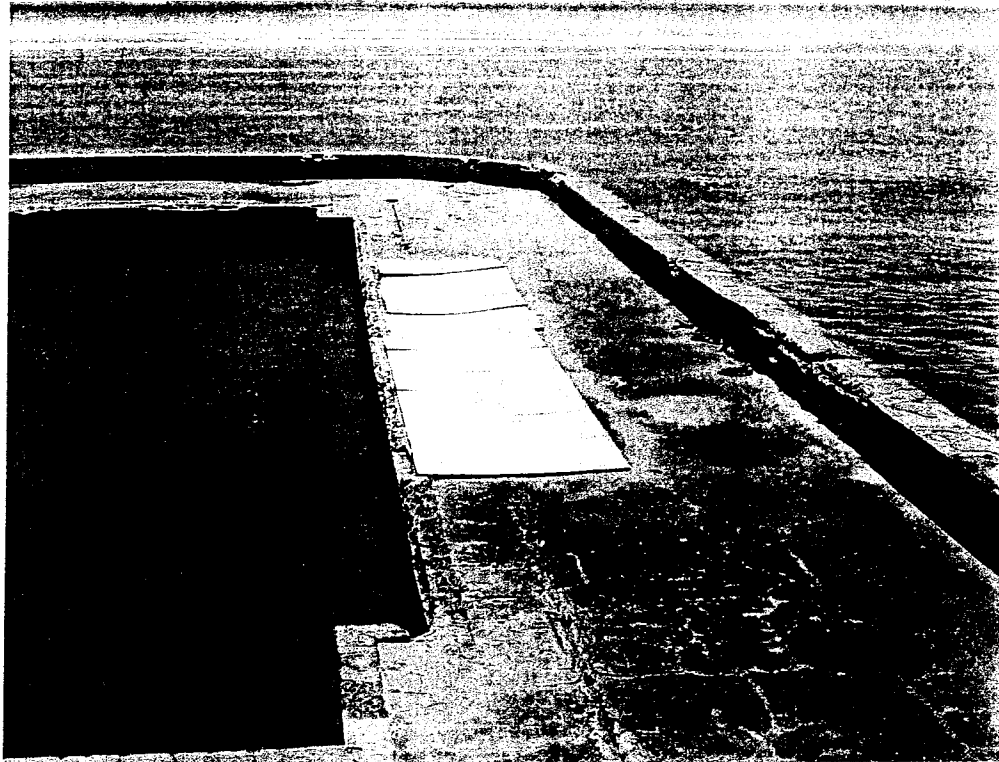
Photo 4 - Pool Deck Collapse – Ewa End

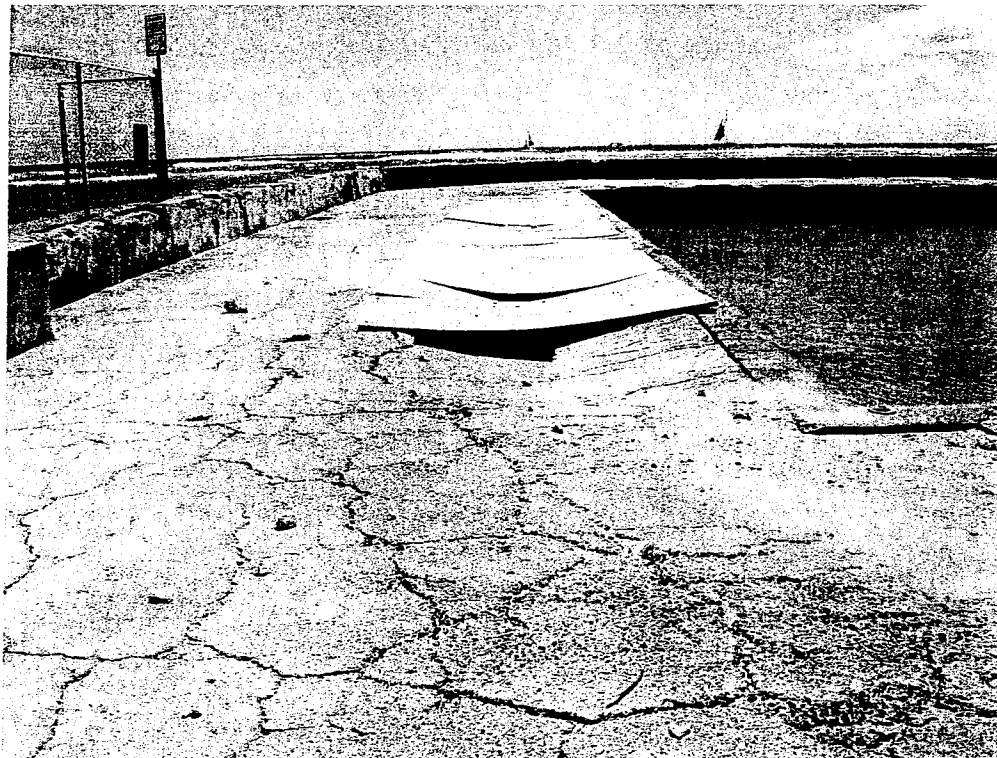
The concrete pool deck slab and beams shows signs of severe distress in several areas as evident by extensive concrete cracking, excessive deflection and obvious signs of corrosion. In some locations, there are cracks or sections where concrete had fallen away which were large enough to see into the water below the pool deck (Photo 8). There are also several locations where the deck slab has cracked along lines that appear to be located directly above the original concrete beams. The slab cracks often appear to extend the full depth of the 1949 concrete topping slab. It is clear that these areas each display signs that indicate structural distress and possible imminent collapse (See Photos 5, 6, 7, 8 & 9 where crack propagates full depth). In fact, photos taken in 1989 appear to show a section of the perimeter sea wall and pool deck slab that were completely detached from the adjacent section in the same area shown in Photo 9. The 1989 photo showed a vertical separation in the perimeter sea wall, which extended into the concrete deck slab at the corner where ewa wall meets the wall on the makai side of the swim basin. The separation between the two wall segments was wide enough to see into the ocean area beyond the perimeter sea wall.

Photo 5 – Slab Cracking and Deflection at Diamond Head End

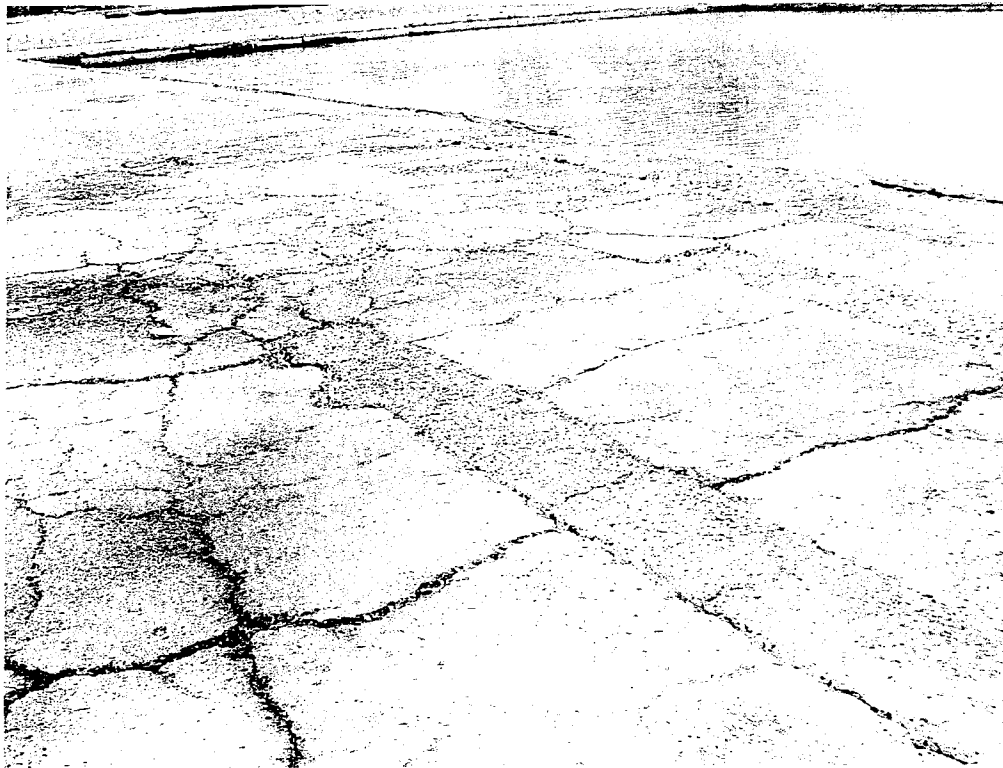
Photo 6 - Pool Deck Cracking and Deflection along the Makai Side

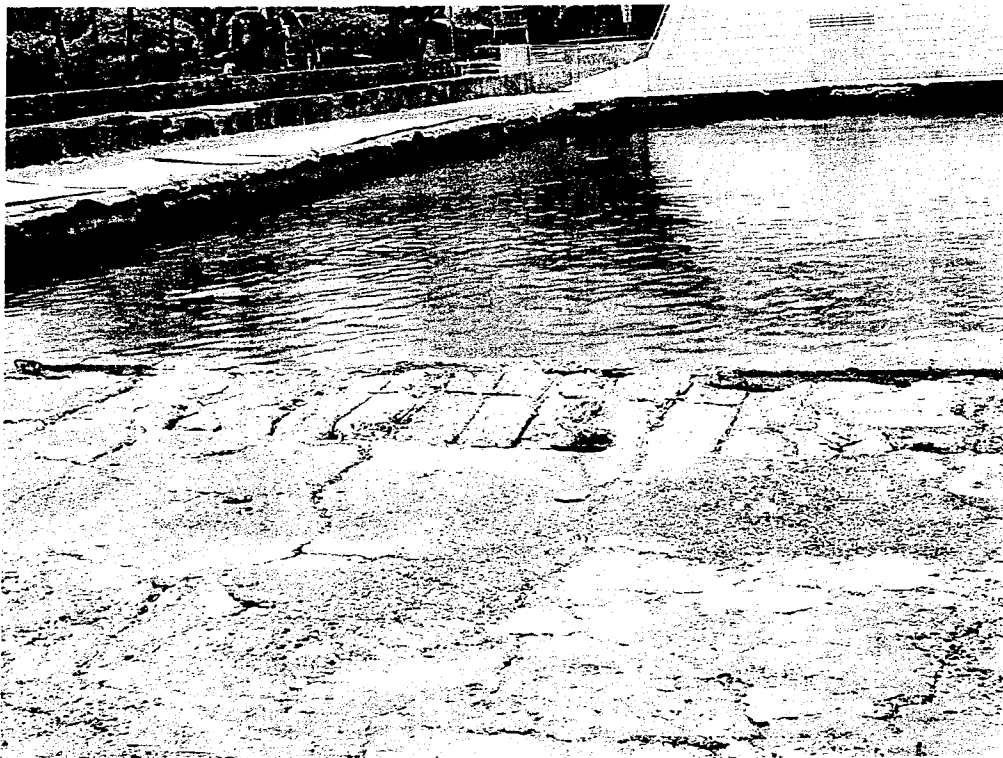
Photo 7 - Pool Deck Beam Spalling and Exposed Reinforcing Corrosion

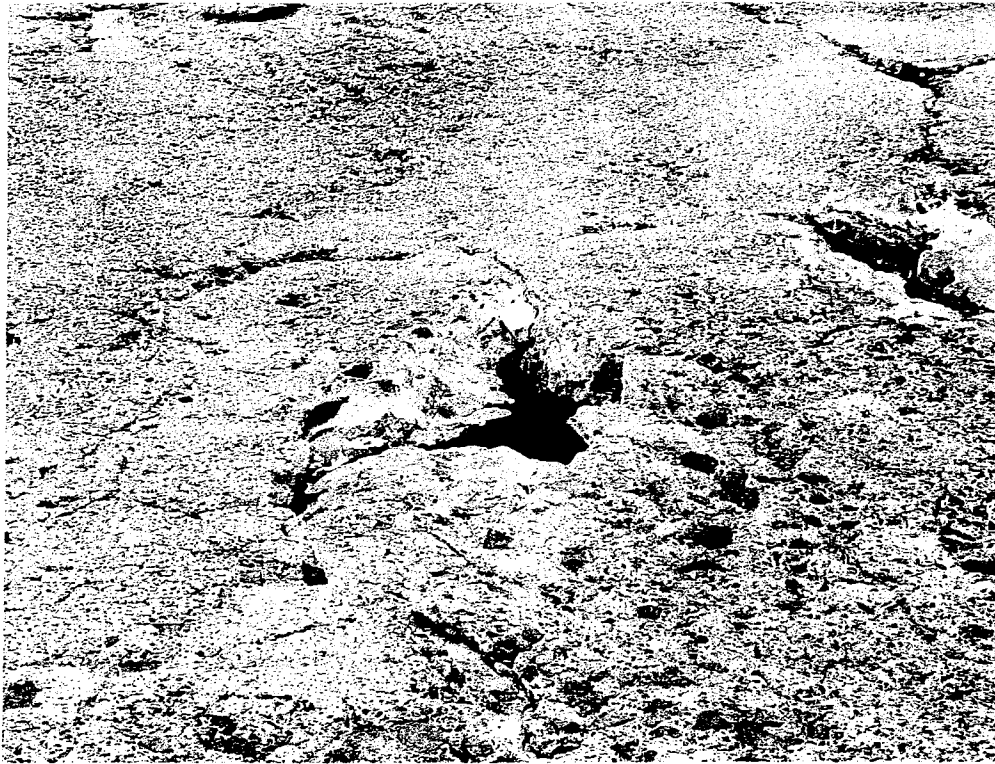
Photo 8 - Pool Deck Slab Deterioration

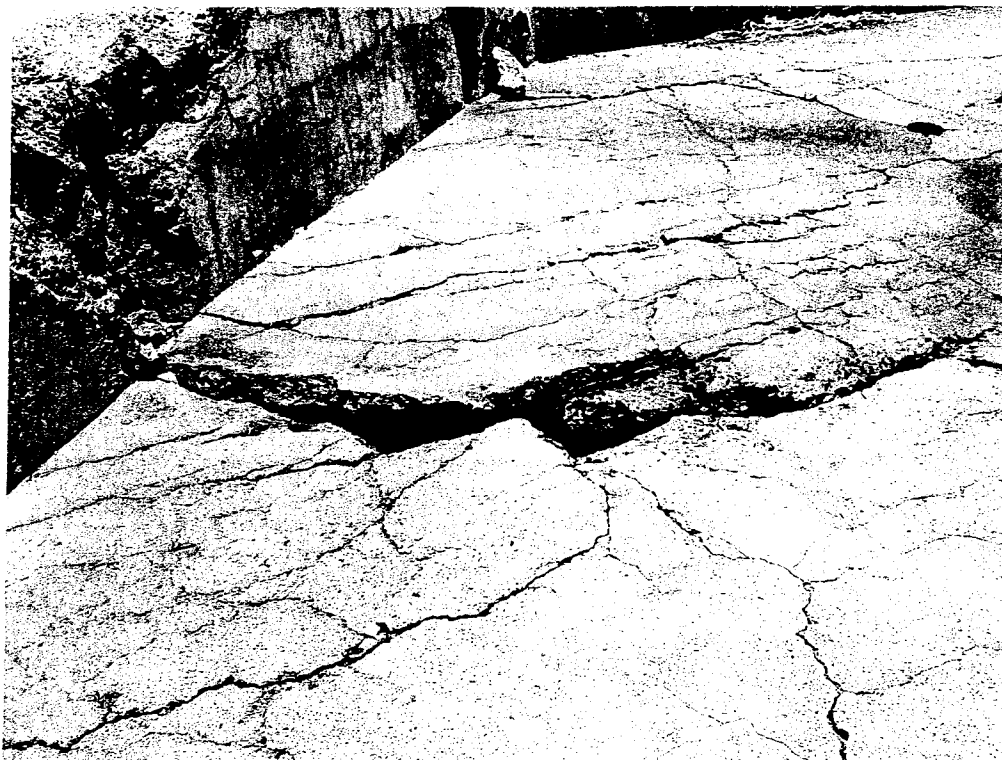
Photo 9 - Pool Deck Slab Deterioration and Corrosion Stains

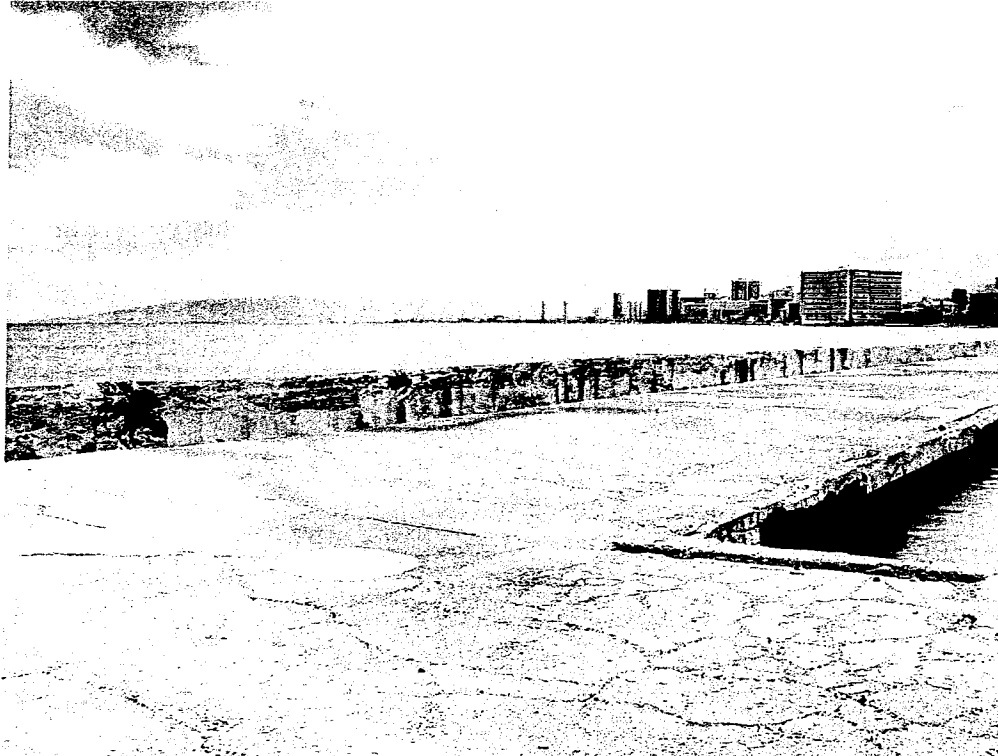
The top section of the swim basin's perimeter concrete sea wall has spalled in numerous locations, often exposing heavily corroded steel reinforcing (Photos 10 & 12). There are numerous segments along the outer face of the perimeter sea wall in which a portion of the concrete had fallen into the ocean (Photo 11). There are also several sections of the precast concrete panels, which run along the interior of the pool deck, that have fallen away from their concrete support beams.

Photo 10 - Deterioration of Perimeter Concrete Wall and Precast Concrete Panels

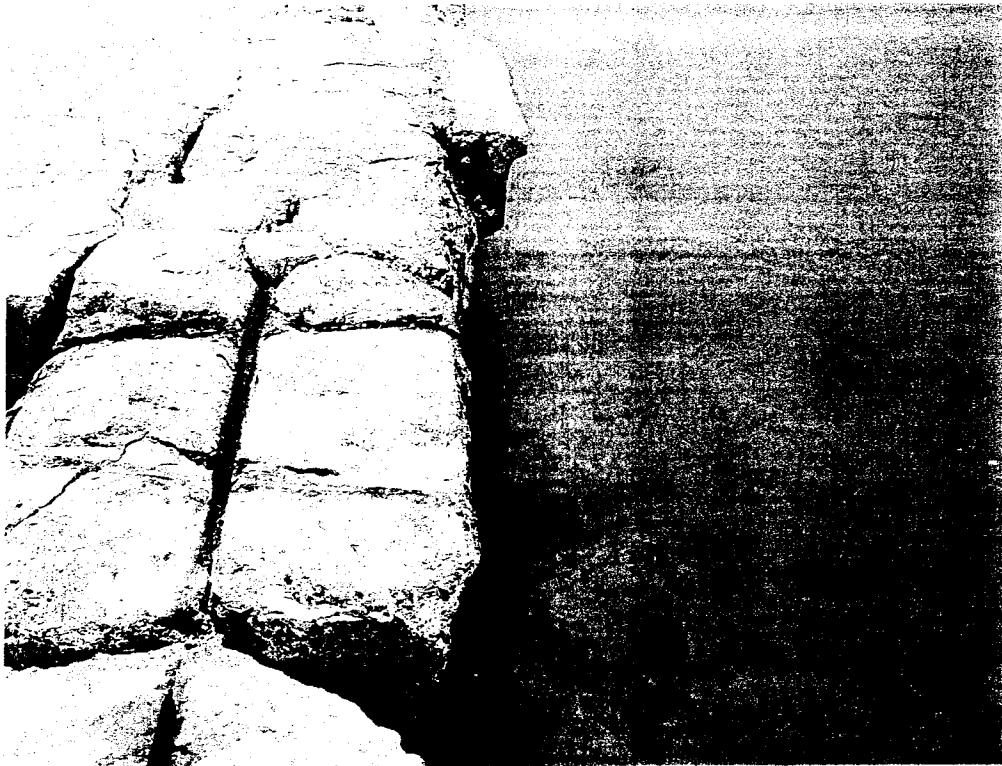
Photo 11 - Concrete Spalling and Reinforcing Corrosion of Perimeter Concrete Wall

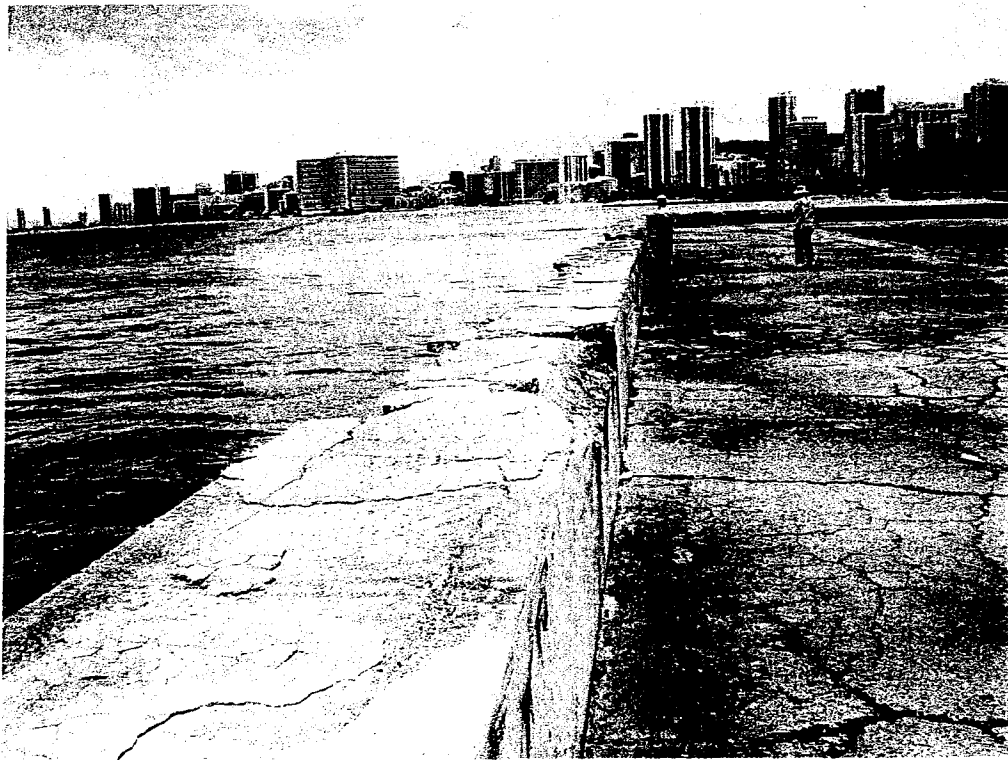
Photo 12 - Concrete Spalling and Deterioration of Perimeter Concrete Wall

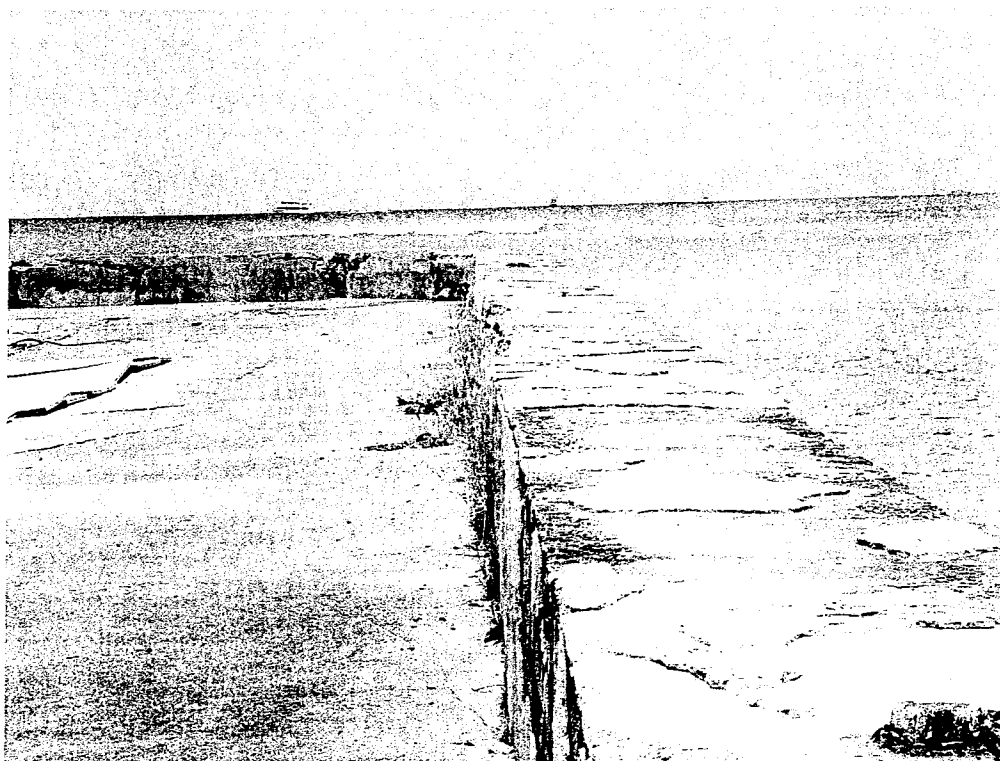
The far makai ends of the perimeter sea walls at the ewa and Diamond Head ends of the swim basin, which run perpendicular to the shoreline, are visibly out of plumb, sloping out away from the swim basin (Photos 13 & 14). The drawings indicate that the support piles are located in a single line along the length of the perimeter wall on the three ocean sides of the swim basin. During our site visit, the representative from the Department of Design and Construction stated that they had observed locations at the bottom of the perimeter sea walls that were no longer bearing on the ocean floor or on the rock infill that was placed below the base of the perimeter sea walls on the ewa and Diamond Head ends of the swim basin.

Photo 13 - Tilting of Perimeter Concrete Sea Wall – Ewa End

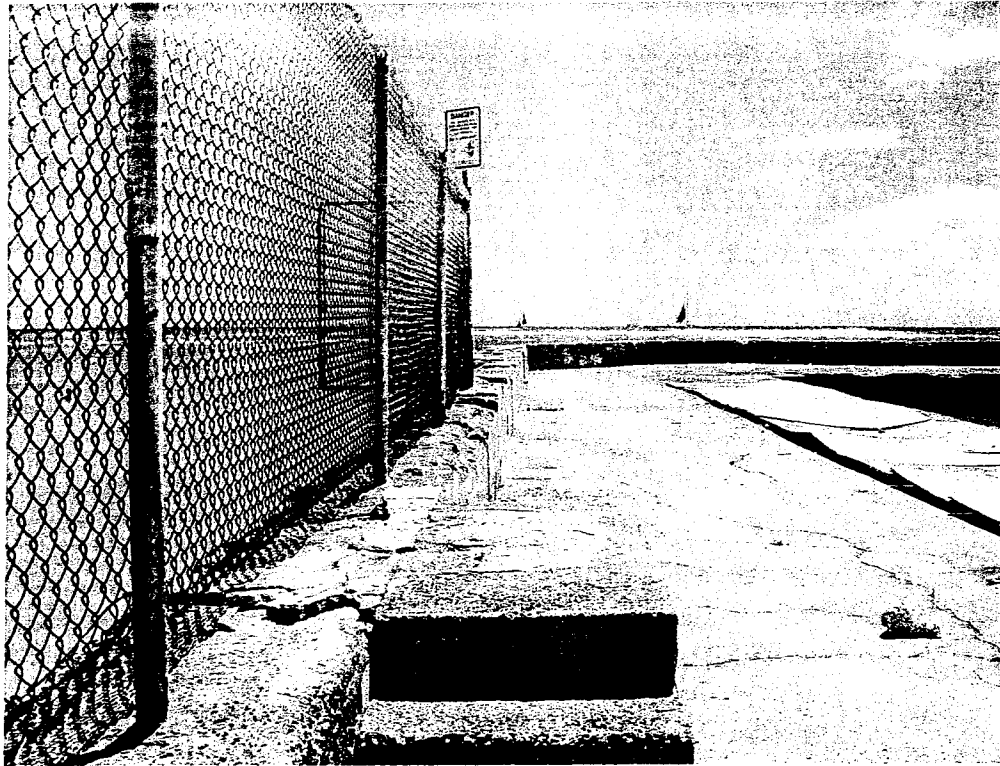
Photo 14 - Tilting of Perimeter Concrete Sea Wall – Diamond Head End

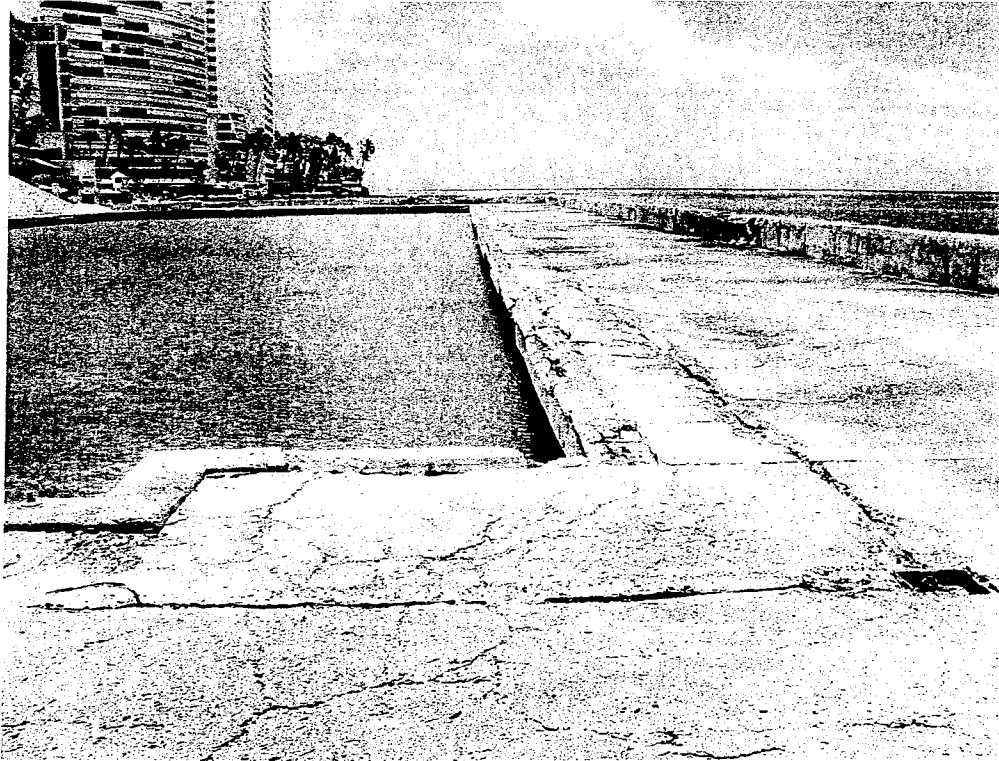
There appears to be a distinct line of steel corrosion and concrete spalling in the ewa/makai corner of the pool deck slab (Photo 15). The 1949 electrical drawings indicate wiring for the pool deck lighting running in approximately the lines where the steel corrosion and concrete spalling occurs. In the area immediately adjacent to the corrosion and concrete spall lines, there appeared to be exposed wiring that was pulled out of the existing concrete deck.

Photo 15 - Pool Deck Deterioration at Ewa/Makai Corner
(Note exposed wiring in the lower left corner of photo)

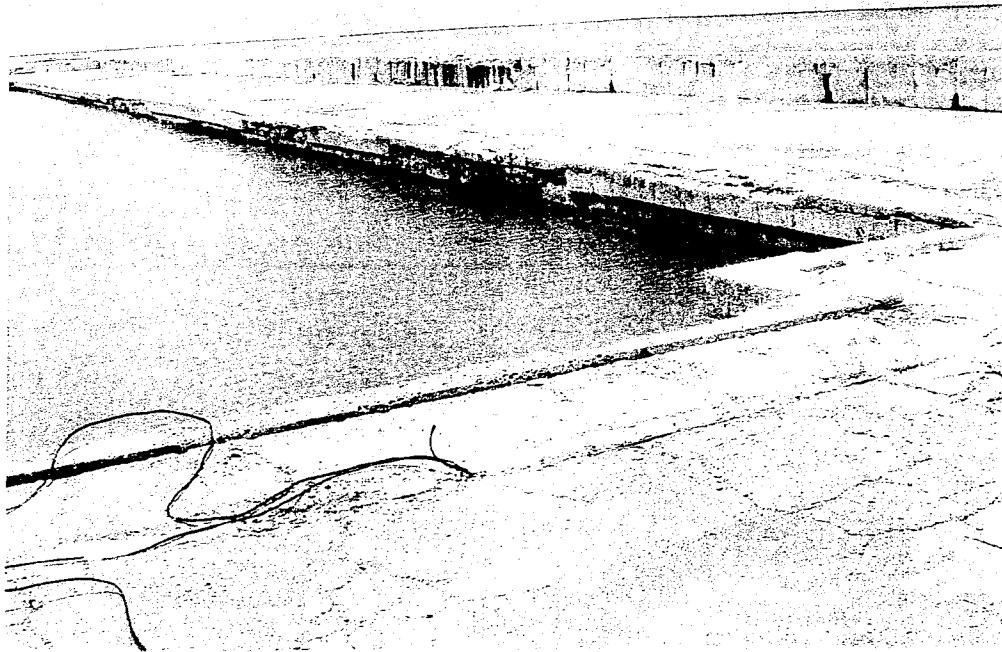
Photo 16 - Pool Deck Deterioration with Exposed Wiring

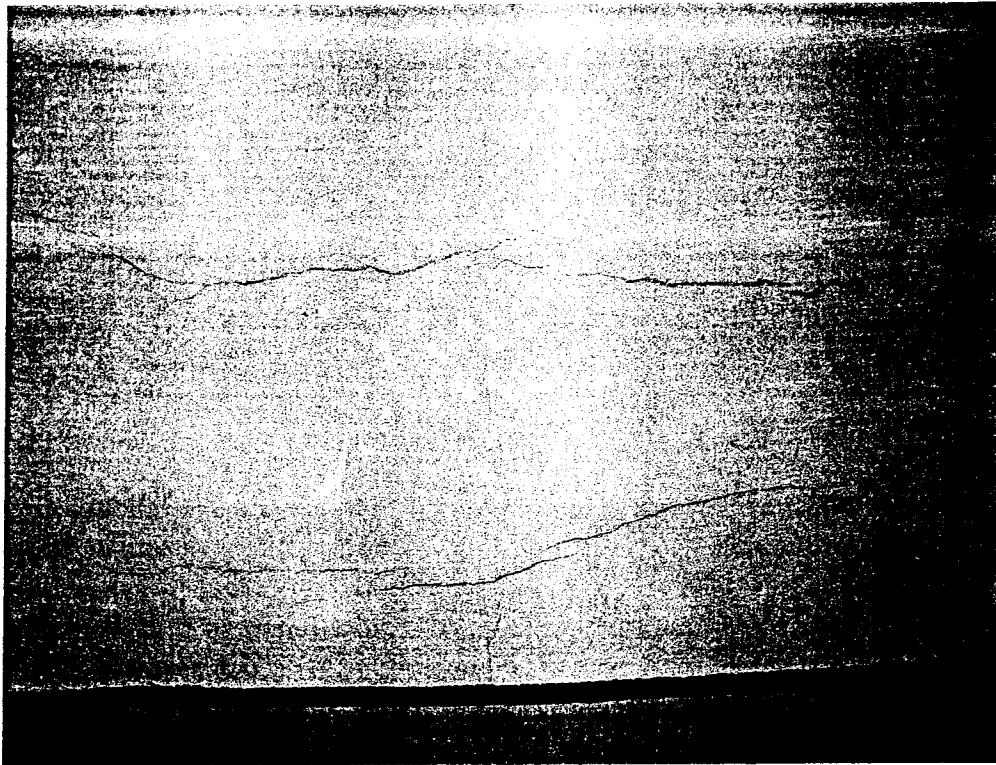
The concrete support beams below the lower section of the bleachers exhibit numerous vertical, diagonal and longitudinal cracks in the plaster finish (Photos 17 & 18). These lower concrete beams bear on the concrete foundation wall on the mauka side of the swim basin. This concrete foundation wall also provides support for the concrete pool deck slab; a portion of which has collapsed.

Photo 18 - Longitudinal Cracks in the Lower Bleacher Support Beam

The cracks observed in the finishes covering the concrete support beams in the lower section of the bleachers are likely due to corrosion of the reinforcing steel. However, it could also be a potential indicator that the supporting foundation wall (Wall "A") is settling and/or rotating away from the bleacher structure resulting in stress cracks in the support beam and finish. During our site visits, the inaccessibility of the foundation wall and the finish that covered the bleacher support beams precluded the additional investigation required to support a conclusion. The cracks observed in the archway over the main entry are a possible indicator of foundation settlement in that location. We recommend that the archway and bleacher supports and foundation be monitored for any additional settlement or movement. Deflection gages or elevation surveys could establish if the structure is experiencing ongoing settlements. If the foundation settlement progresses, possible schemes for stabilizing the structure could be investigated.

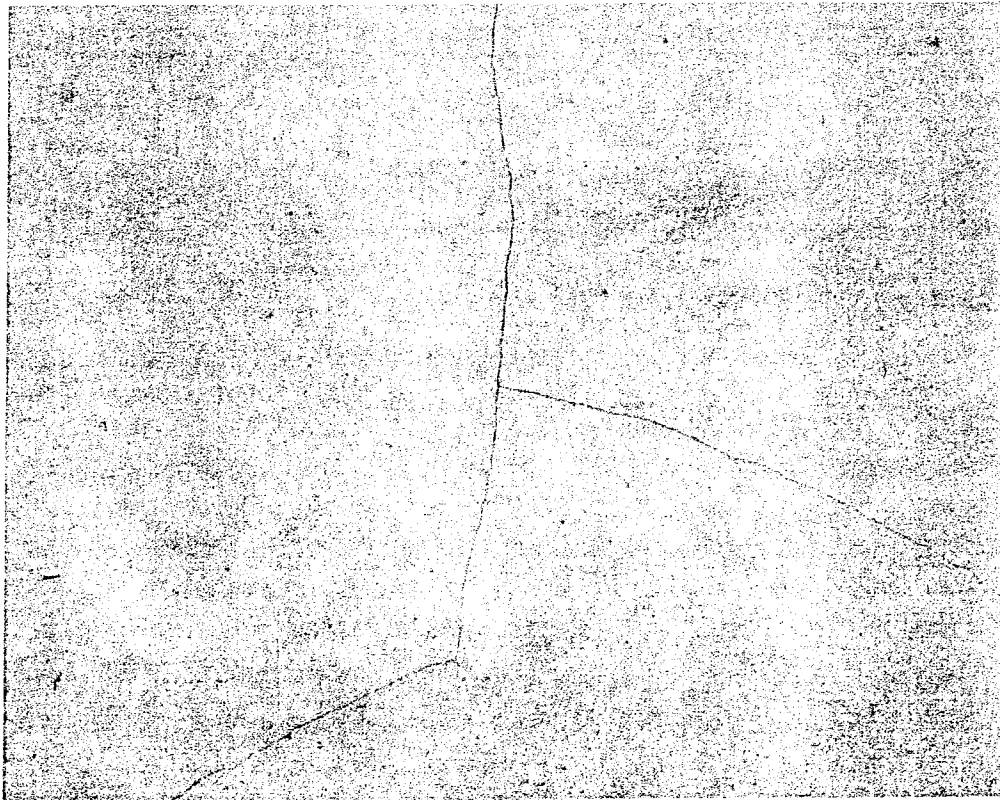
There were numerous cracks observed in portions of the concrete slab-on-grade floor below the bleacher structure (Photo 19). The original slab-on-grade was reportedly removed and replaced during the restoration project in 2000. However, the 2000 renovation drawings indicate that only the exterior slab-on-grade located on the ewa and Diamond Head sides of the bleachers and at the entry archway was replaced with a new 6" reinforced slab-on-grade. In any case, there does not appear to be any slab expansion joints in the areas that were observed below the bleachers.

Photo 19 – Slab-on-grade Floor Cracking

The cracking of the slab-on-grade floor below the bleacher structure appears to be the result of shrinkage, possibly due to the lack of expansion joints, or the result of settlement of the subgrade. However, this does not appear to be an urgent structural issue.

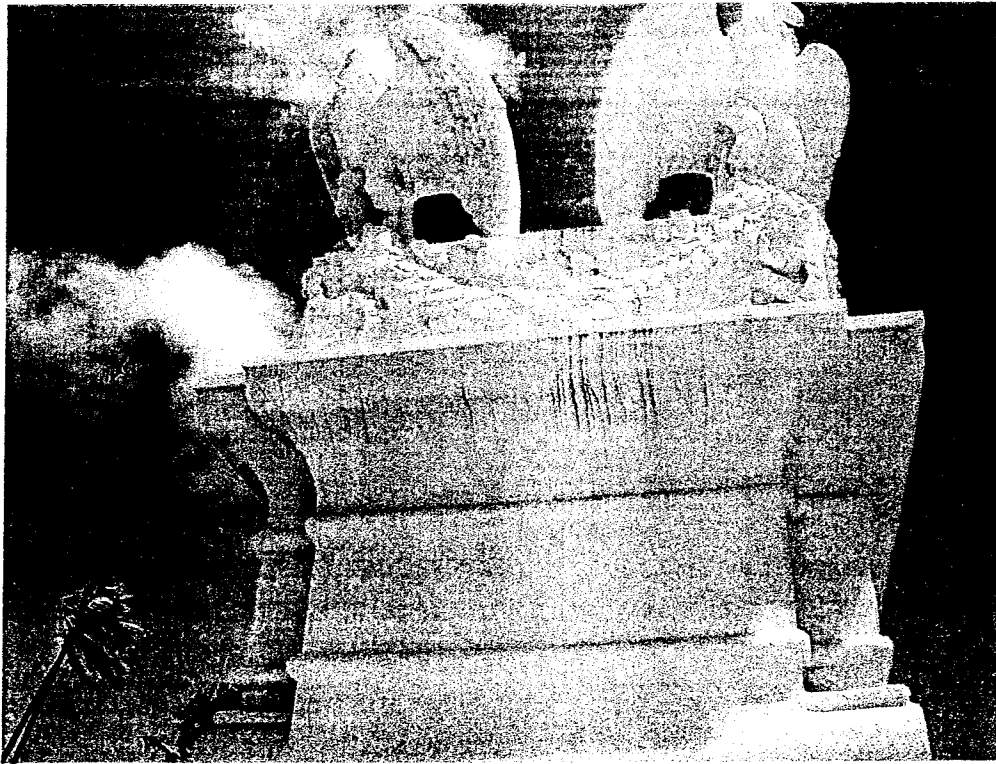
The archway over the main entry to the natatorium shows potential signs of the progression of corrosion as indicated by stains possibly caused by rust leaching on the finished surface (Photo 20).

Photo 20 - Stains on the Entry Arch Finish

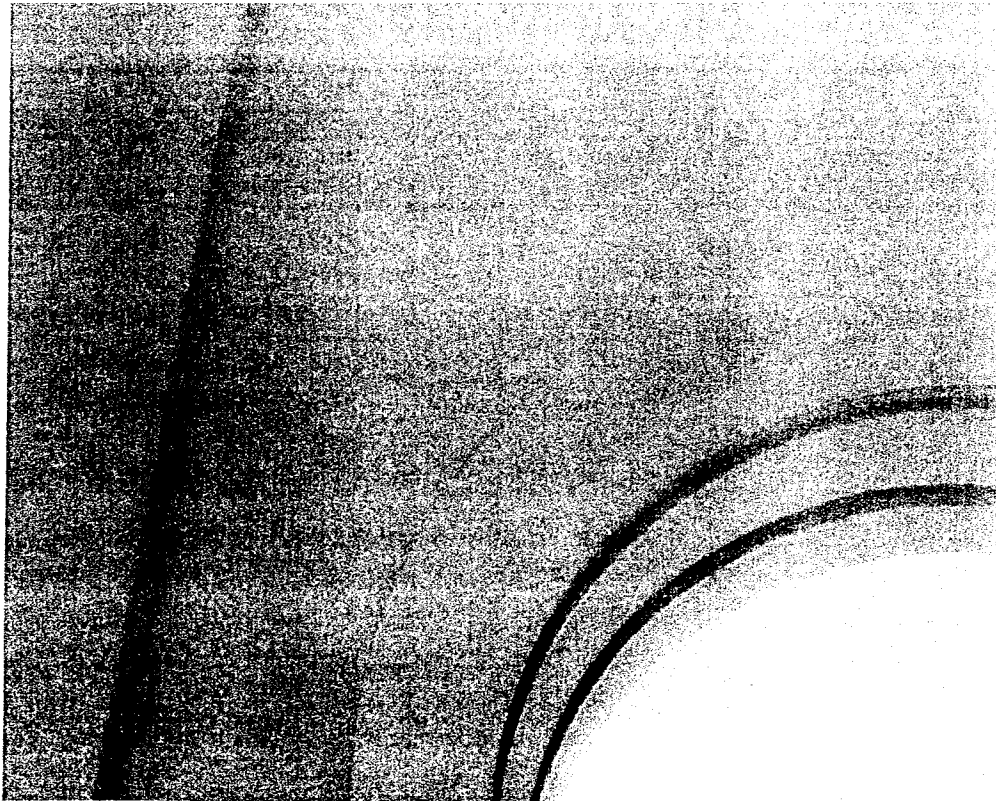
In addition to the signs of corrosion, cracks were observed in the finish of the archways over the main entry to the natatorium. The representative from the Department of Design and Construction stated that these cracks did not occur prior to the restoration work in 2000 (Photos 21, 22 & 23).

Photo 21 - Cracking in Entry Archway Finish

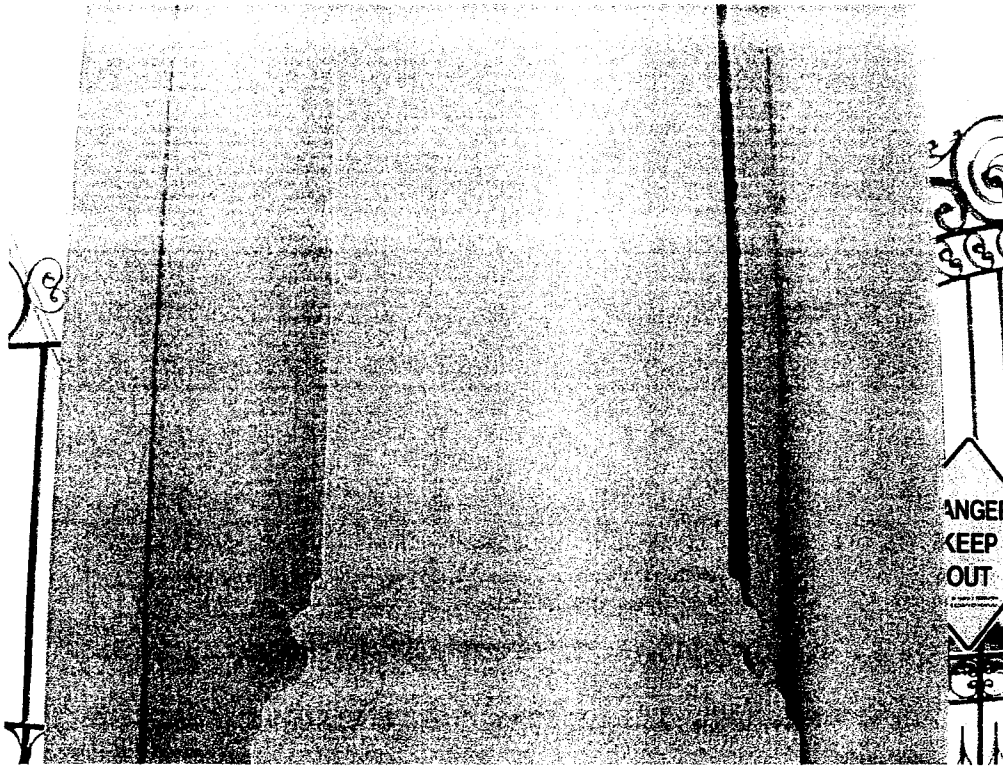
Photo 22 - Cracking in Entry Archway Column Finish

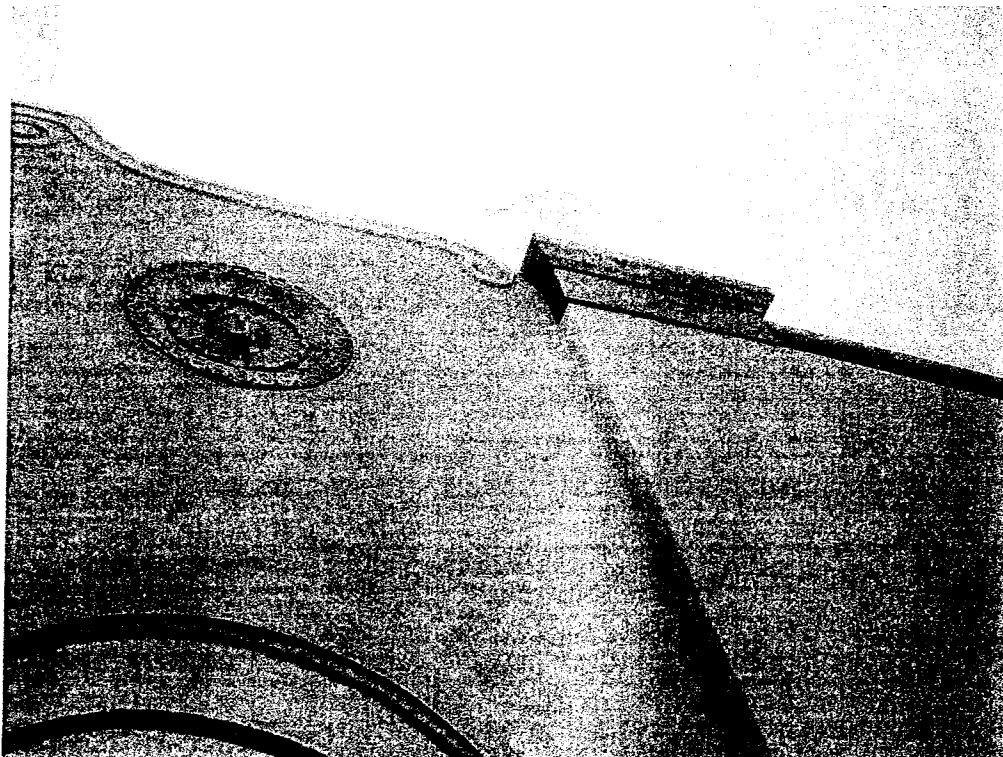
Photo 23 - Cracking in Entry Archway Finish

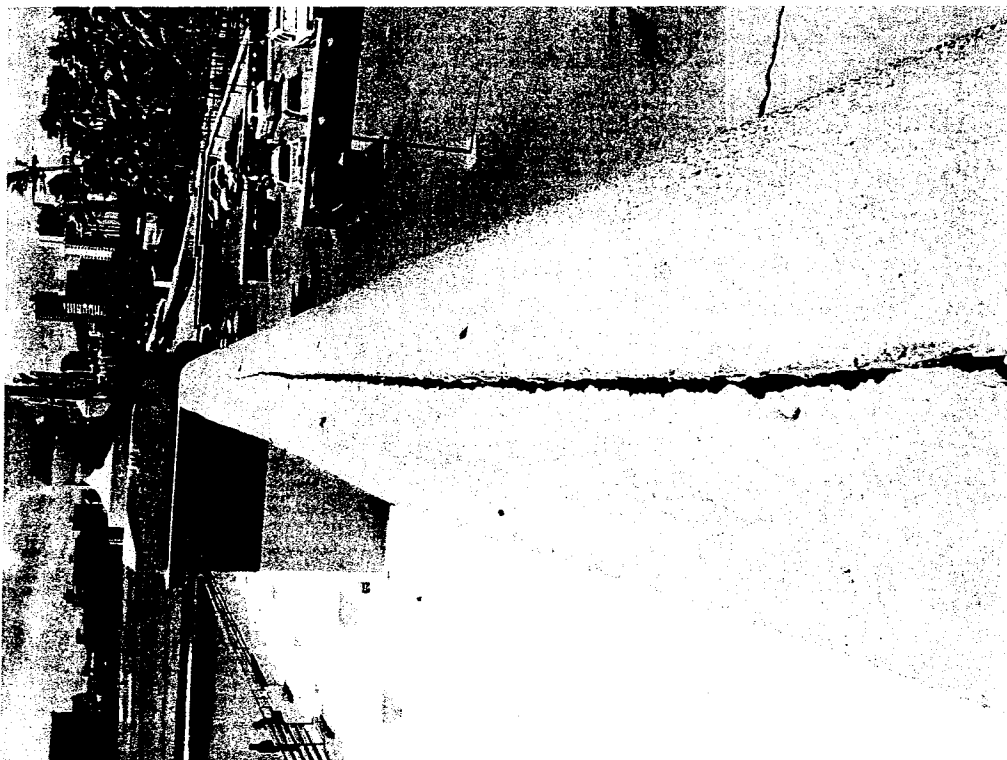
Photo 26 - Cracking at Top of Bleacher Seating Wall Finish

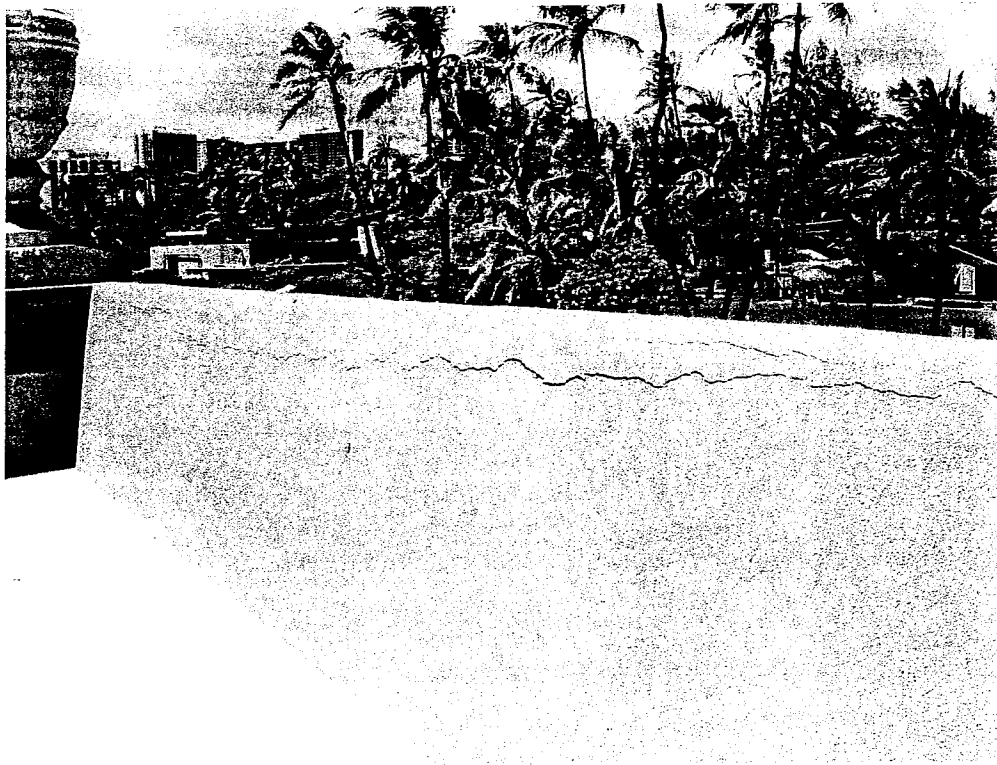
Photo 27 - Cracking at Top of Bleacher Seating Wall Finish 2

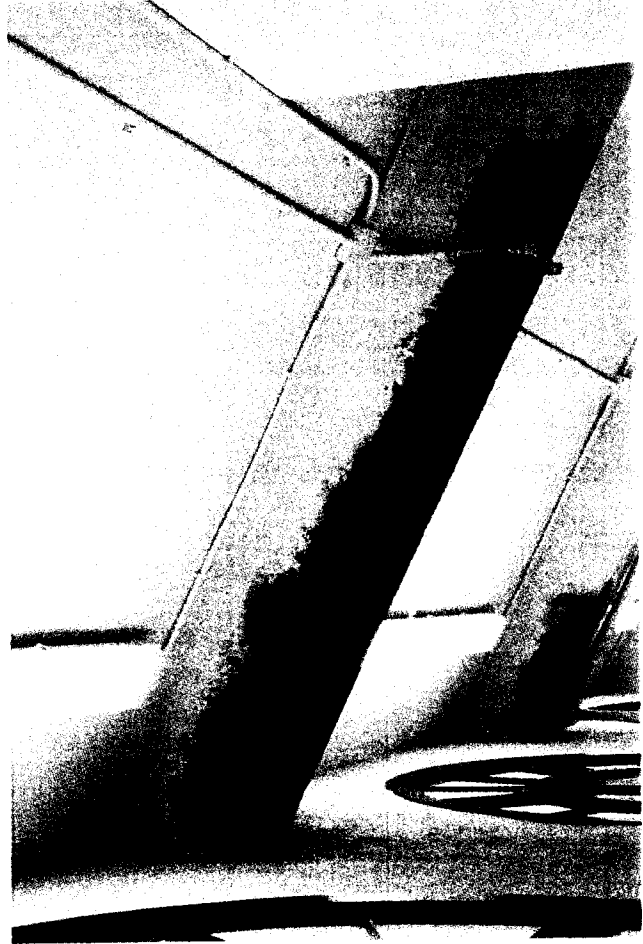
Photo C. Supporting beam crack repair.

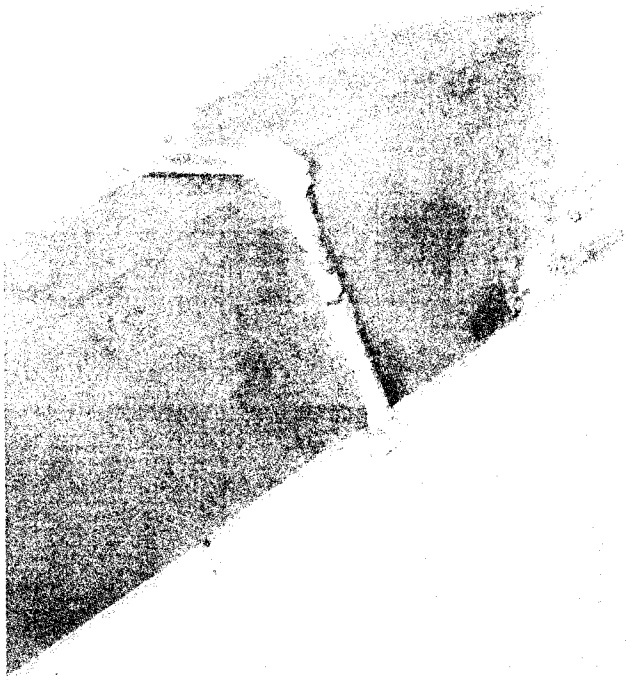
Photo D. Supporting beam crack repair.

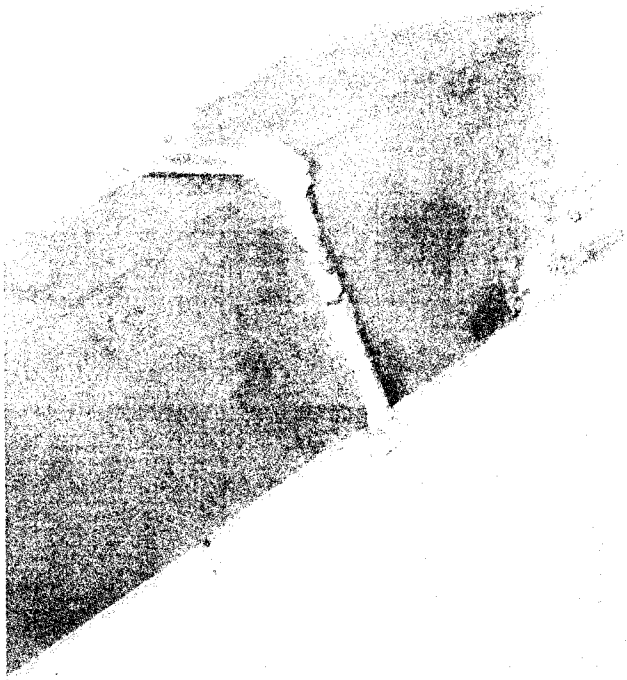
Photo B. Wall cracks.

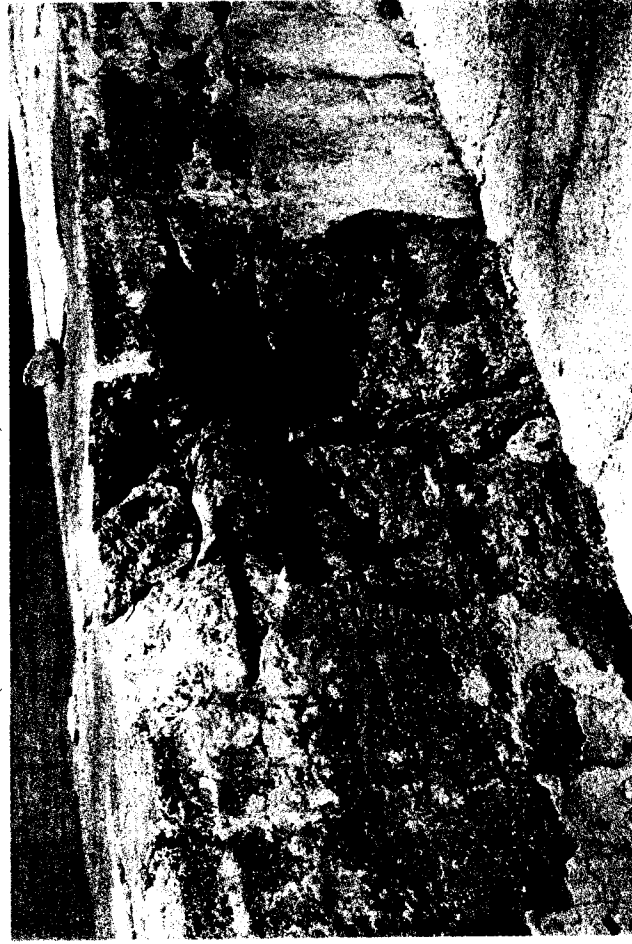
The sea wall surrounding the pool area is in poor condition. The photos in Figure 2 show extensive and severe cracking. There are areas of the wall where corrosion has completely eliminated the reinforcing. Retrofit of the sea wall is not possible. Extensive reconstruction of the sea wall is necessary. In some areas a complete replacement of sections may be necessary.

Photo C. Sea wall (side delamination).

The pool deck and sea wall are deteriorated to the point that retrofit is not possible. It is recommended that the pool deck and sea wall be repaired as a measure for public safety.
