RE: Waikiki War Memorial Natatorium

**EXISTING BUILDING STRUCTURAL
CONDITION REPORT**

WAR MEMORIAL NATATORIUM

EXISTING BUILDING STRUCTURAL CONDITION REPORT
WAR MEMORIAL NATATORIUM

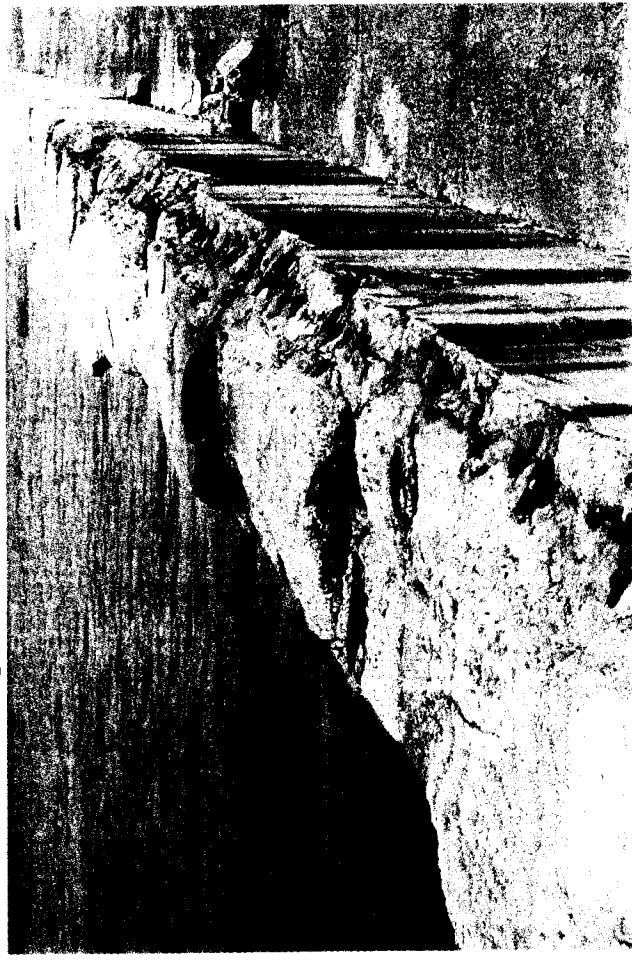
The sea wall surrounding the pool area is in poor condition. The photos in Figure 2 show extensive and severe cracking. There are areas of the wall where corrosion has completely eliminated the reinforcing. Retrofit of the sea wall is not possible. Extensive reconstruction of the sea wall is necessary. In some areas a complete replacement of sections may be necessary.

Photo D. Seal wall.

The pool deck and sea wall are deteriorated to the point that retrofit is not possible. It is recommended that the pool deck and sea wall be repaired as a measure for public safety.

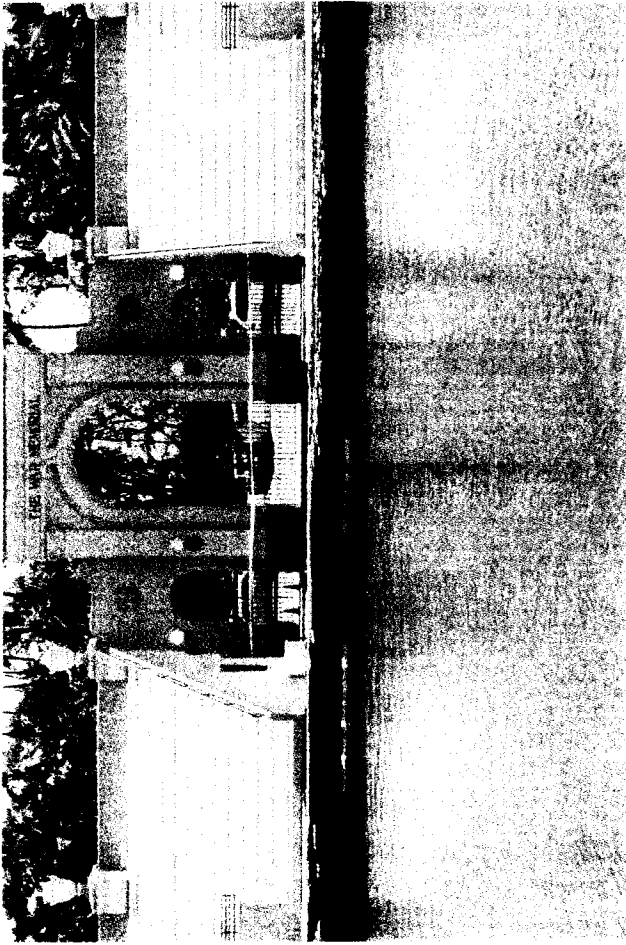
The structural elements of the Waikiki War Memorial Natatorium were exposed to the different mechanisms of cracking during its lifetime. The resulting deterioration is evident in the photos shown. Sections of the pool deck have failed and fallen into the water. A section of the failed pool deck at the entrance is shown in Figure 3. The collapsed deck is located between the bleachers and in the vicinity of the arch entrance to the War Memorial. The location is shown in Photo "A." Close-ups of the failed deck are shown in Photos "B," "C" and "D."

Photo A. Collapsed deck at central archway.

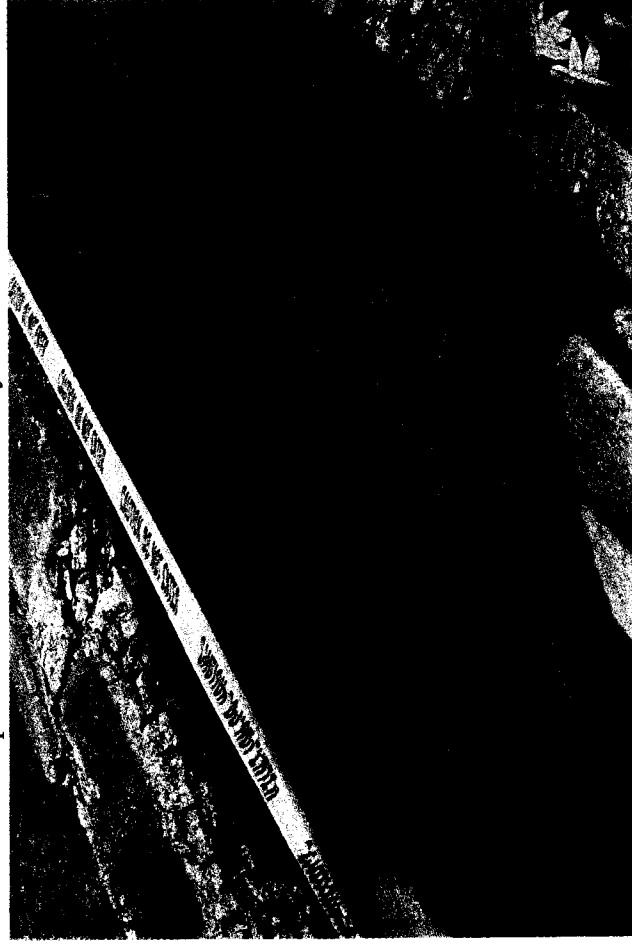
The photo in the lower left-hand side (Photo "C") is another view of the collapsed deck. It is speculated that there are areas of the pool deck under similar circumstance and on the verge of falling into the water. The pool deck is structurally unsound and on the verge of failing. The deck is not recoverable and there is no means of retrofitting it. It is strongly recommended that the public be kept off the pool deck. The fourth photo in Figure 3 (Photo "D") is taken at another location of the deck. Here the failure section is not as large, but adjoining sections may combine with the smaller section and collapse at any time.

Photo C. Collapsed deck at entrance.

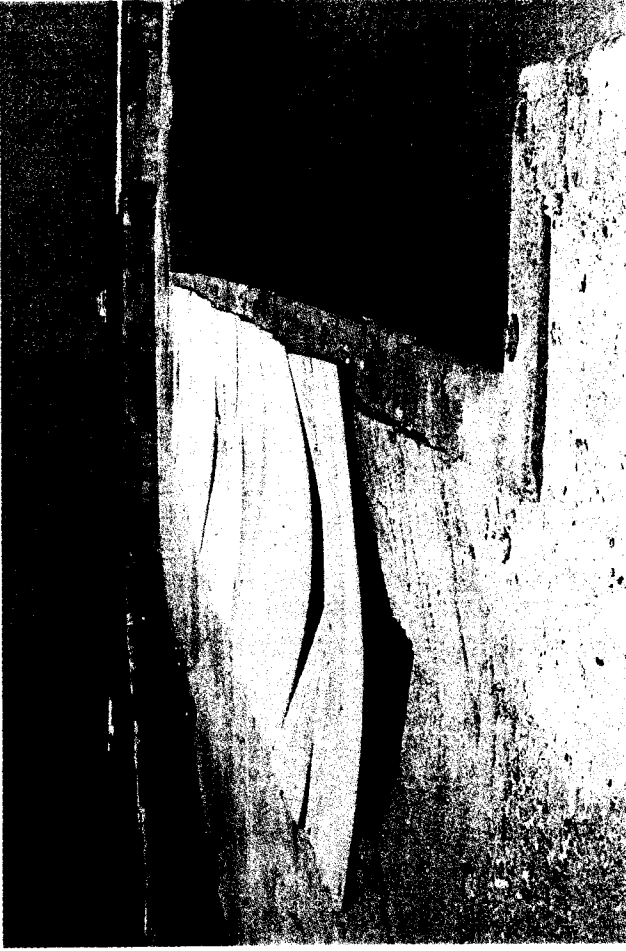
Figure 4 summarizes the status of the pool deck. Photo "A" shows the delamination of the pool deck along the perimeter of the pool. In the background the renovated bleachers are shown. Photo "B" shows the collapsed deck at the diamond-head end of the pool deck. A similar collapsed section at the opposite, Ewa-end, exists but is not shown in the collection of photos. The two bottom slides (Photos "C" and "D") are photos of the pool deck with extensive cracks. The two photos represent the typical condition of the pool deck.

Photo B. Diamond Head deck.

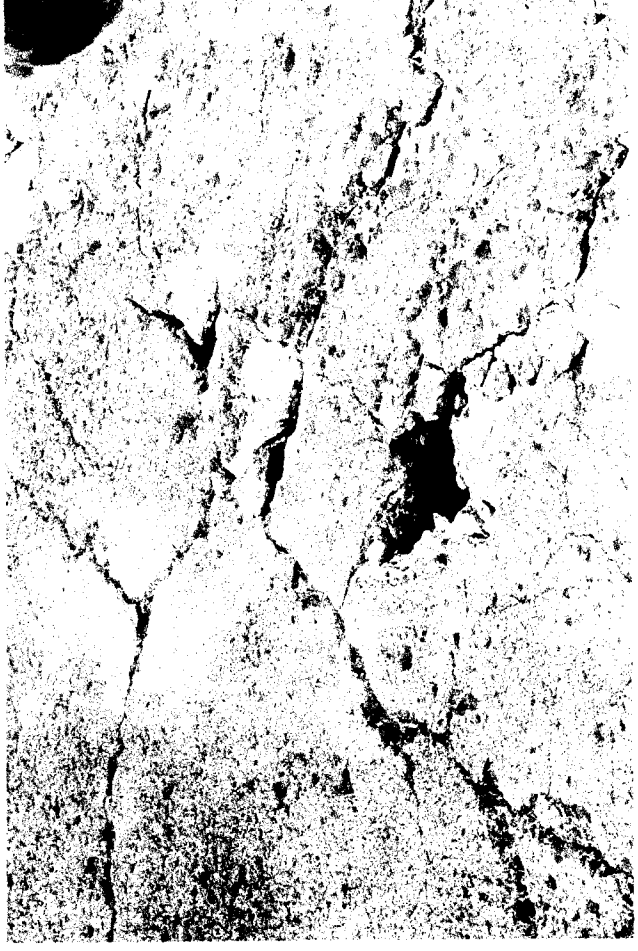
Photo D. Pool deck.
